Conference  
and Exhibition

LAS VEGAS, NEVADA  
Red Rock Resort  
September 24–26, 2018

# Polyethylene pipeline performance against earthquake

- Hideki Omuro  
Tomokazu Himono  
Kubota ChemiX Co., Ltd.

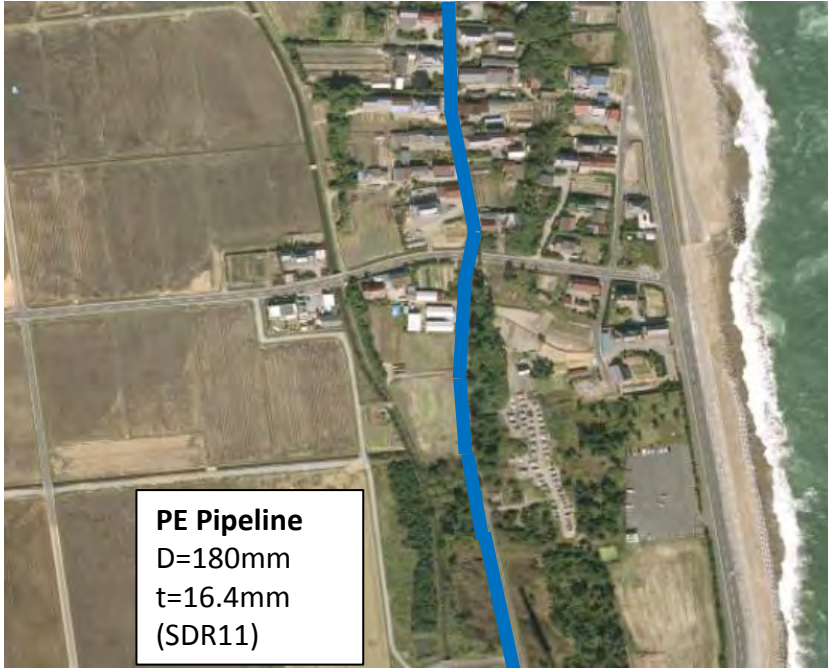
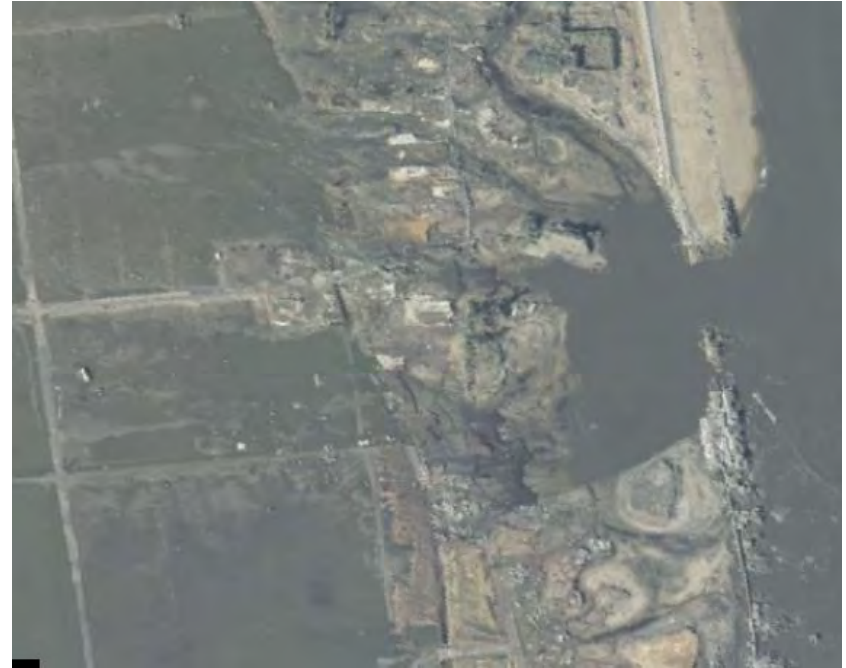
Before “Tsunami”

After “Tsunami”

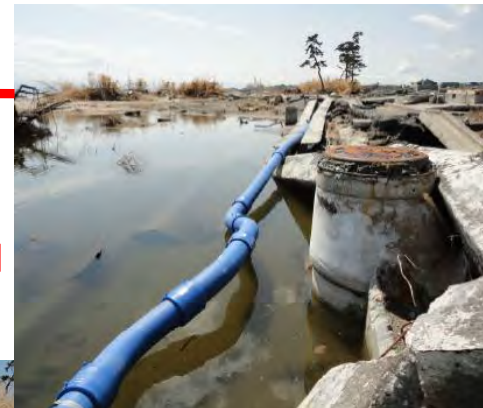
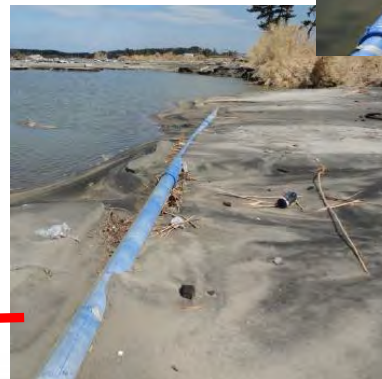
Destroyed seawall

PE Pipe was not broken  
where the seawall is  
not destroyed.

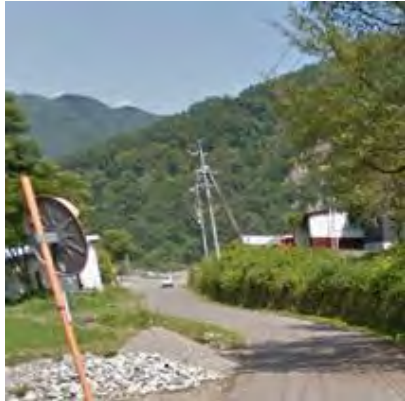
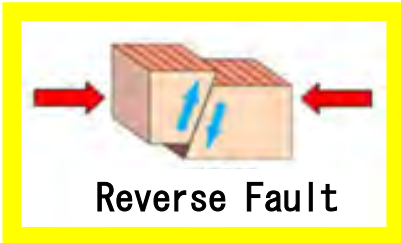
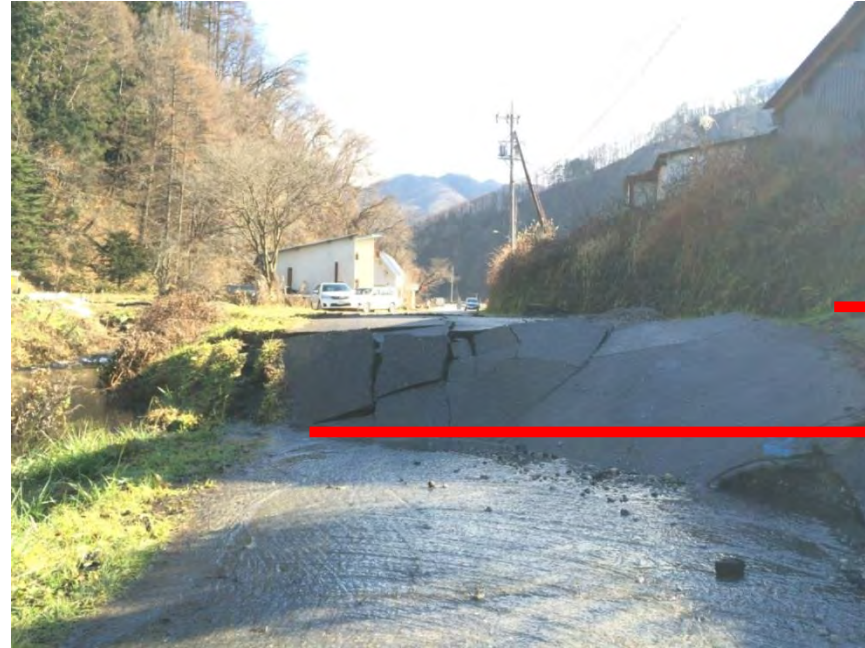
80cm

Before earthquake

After earthquake

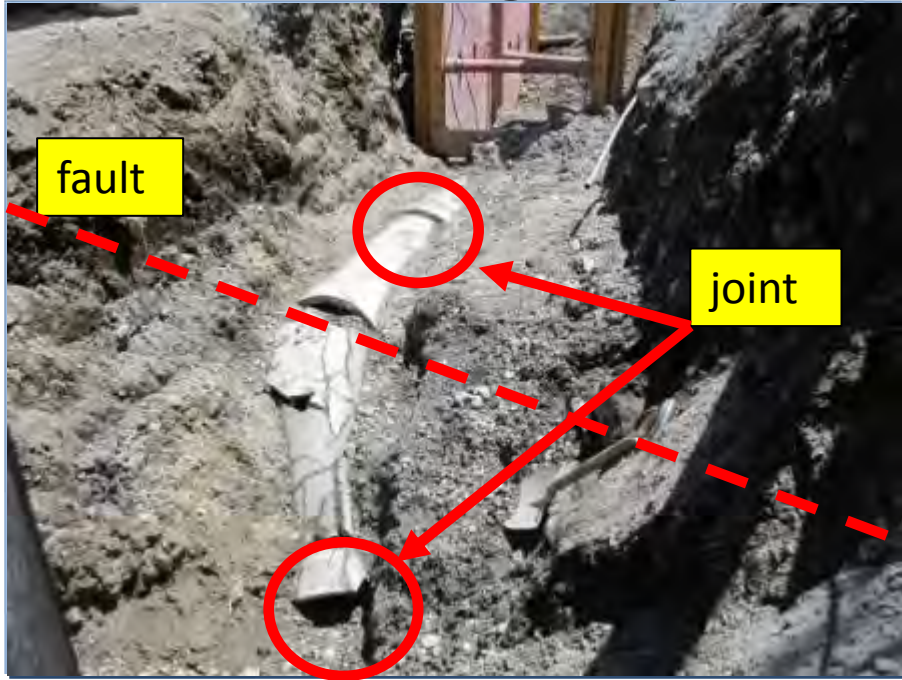
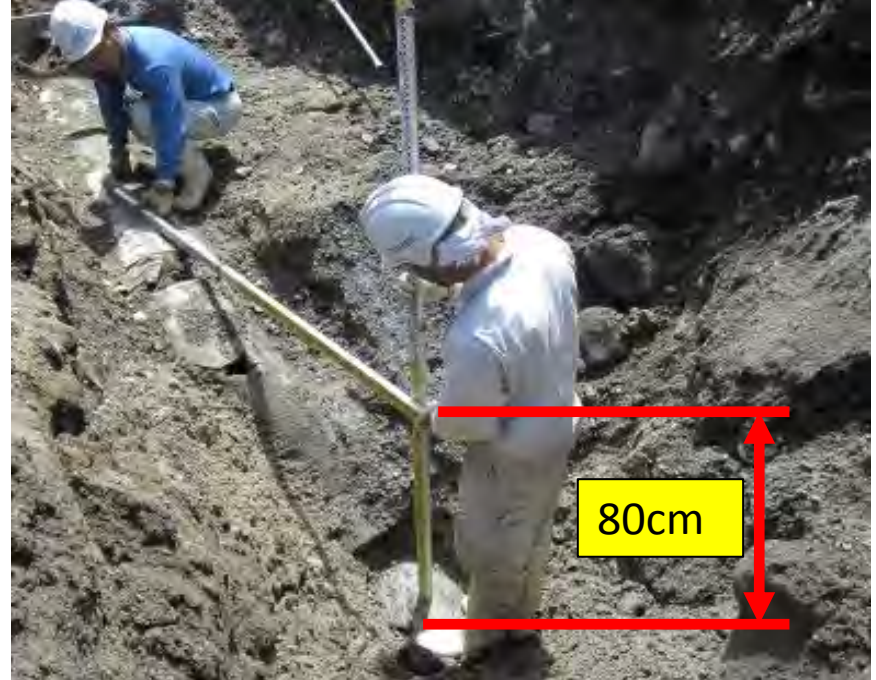
**Destroyed sewer pipeline (Reinforced concrete pipe :450mm)**
