Pre-chlorinated Pipe Bursting Invigorates Arlington Water Utilities Main Replacement Program

City of Arlington & Water Main Background

Program Overview

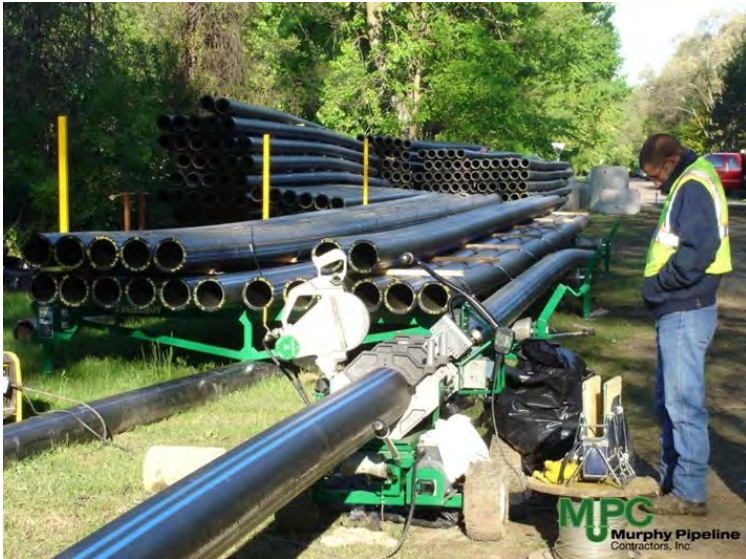
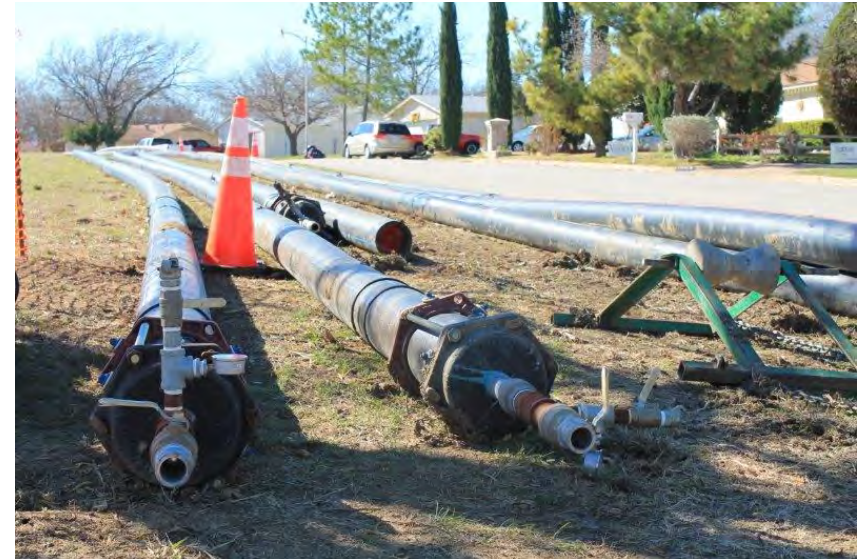
Fusing & Pre-chlorination of HDPE

- Staging area located away from burst locations to minimize site impact
- Butt fusion is used to connect pipe sections to corresponding burst lengths
- Pressure testing
- Lines capped and disinfected with hypochlorite solution of at least 25 mg/L
- Two consecutive days of samples, taken 24 hours apart

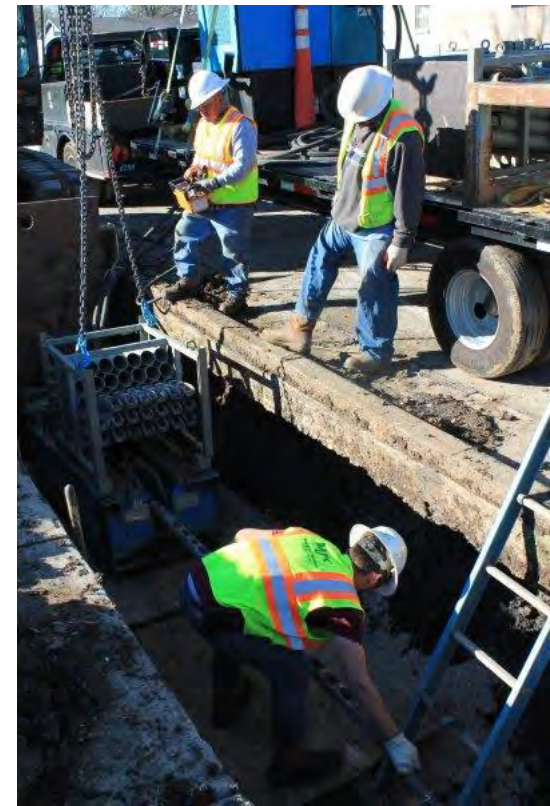
Pipe Bursting Operations 8:00 AM

- Entry and exit pits excavated 4' x 12'
- Service connections pits 3' x 3'
- 8:00 AM – Decommission Main
- Bursting equipment is set in pit and rods are shuttled through host pipe

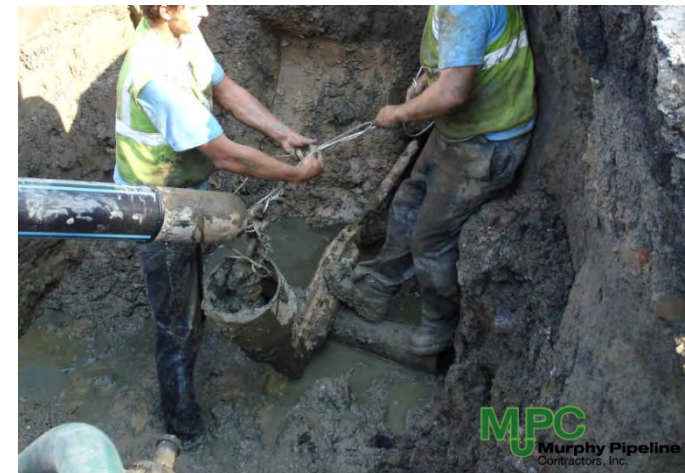
Pipe Bursting Operations 10:30 AM

- 10:30 AM – Bursting head (or ductile splitter) and expander are attached to the rods which have reached the entry pit
- Pre-chlorinated and sealed HDPE pipe attached to the expander
- Pull back begins

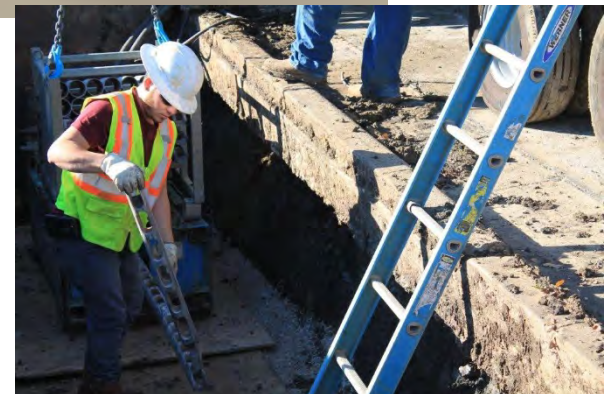
Pipe Bursting Operations Noon

- Rods are removed from the exit pit as pipe is pulled into place
- Noon – New pipe is installed

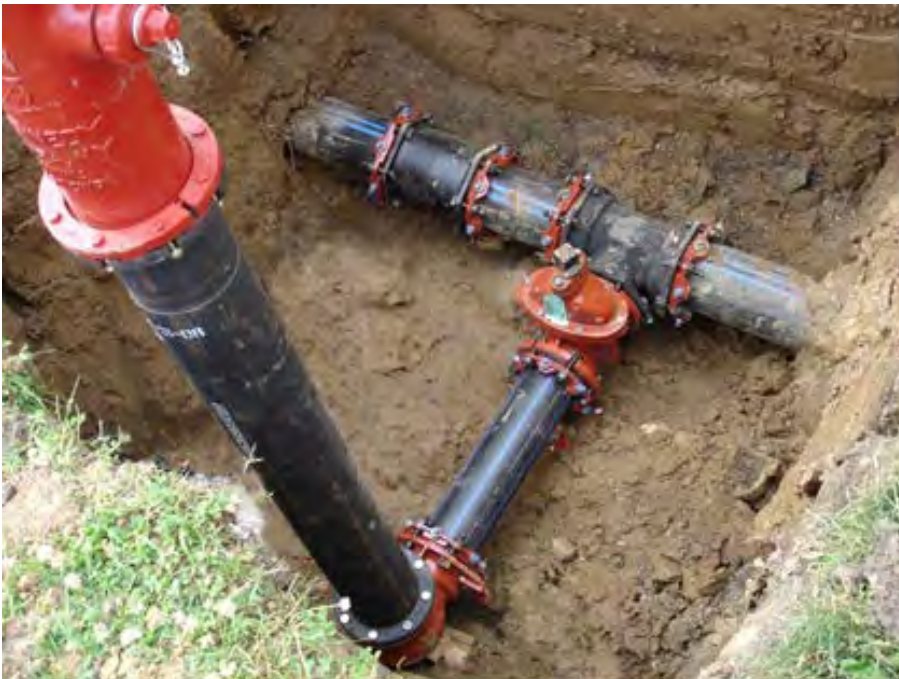
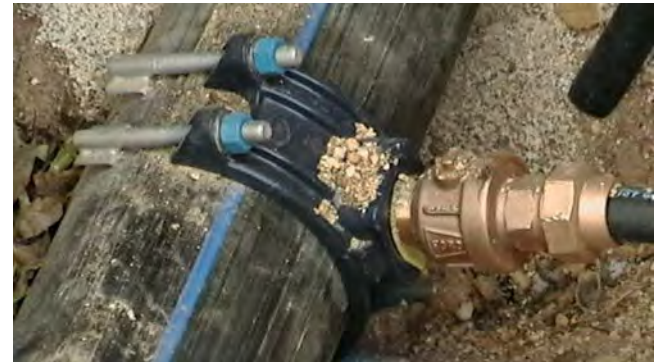
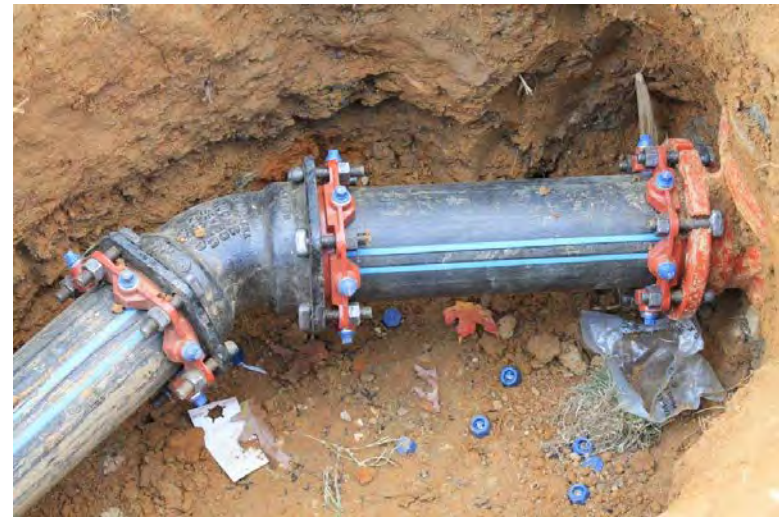
Pipe Bursting Operations Noon to 3:00 PM

- Noon to 3:00 PM – Connections made
- Ductile Iron fittings, mega lugs, stainless steel inserts, mechanical service saddles

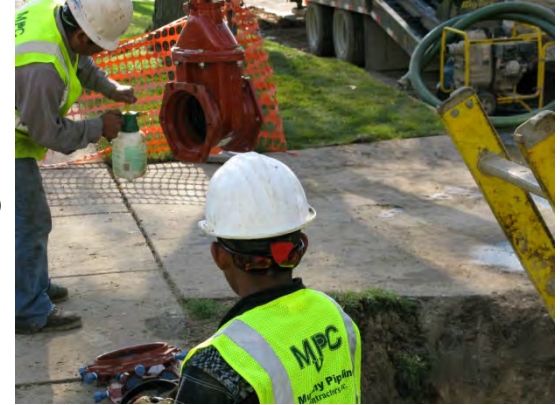
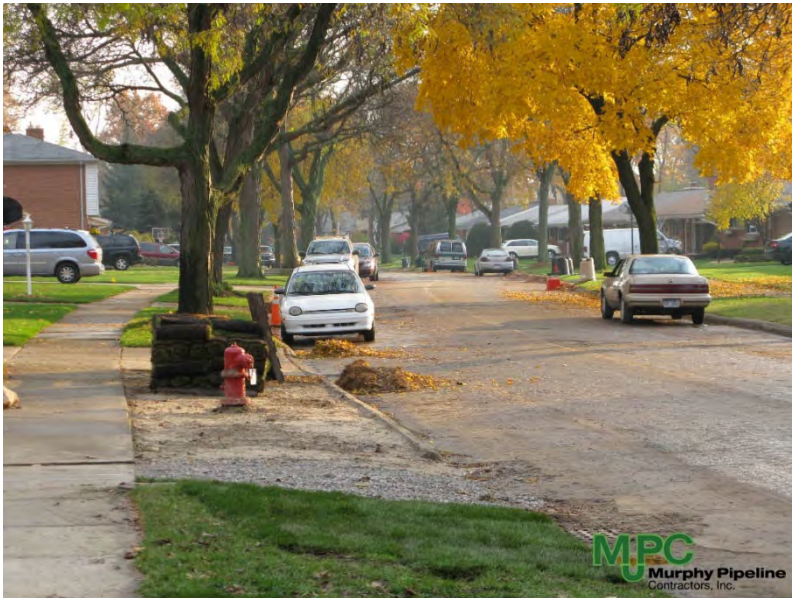
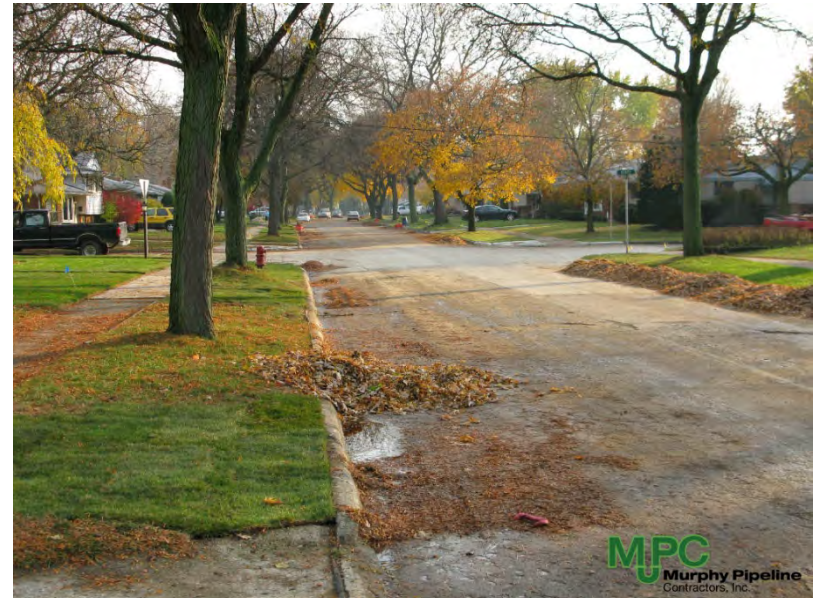
Pipe Bursting Operations 3:00 PM

- 3:00 PM – Post Chlorination Process
- Hypo-chlorus solution sprayed on all connections
- Super-chlorinate new pipeline with slug of chlorine to 300ppm
- 4:00 PM – New main back live
