CORNFIELD 'TILED' AND PLANTED IN ONE DAY

HDPE Pipe System Resolved Compaction and Drainage Problems

WILLMAR, MN – In one day, how do you install a 24,000 foot drainage system on 40-acres of farm ground and then plant the field with corn? For Terry Vreeman and his 5-man construction crew the answer, according to the Plastics Pipe Institute (PPI), was high-density polyethylene (HDPE) pipe.

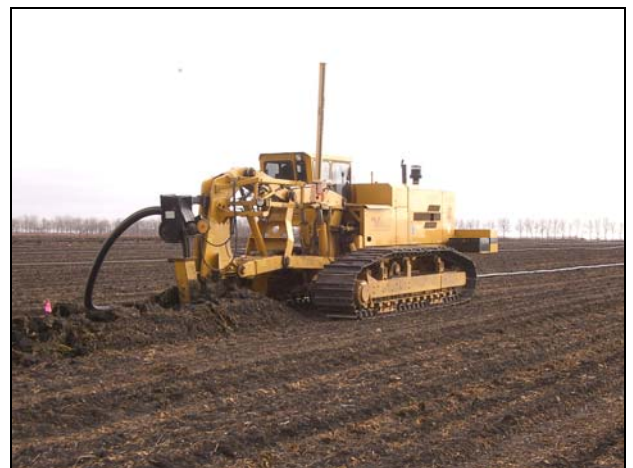
“First, we put in a 12-inch smooth wall pipe in December 2007 that would act as the main,” Vreeman explained. “Then, in the spring of 2008 after the soil was drier, we put in the corrugated high-density polyethylene pipe that most call ‘seepage tile’. There were a lot of quarter-mile long runs so it went very quickly with the pipe coming directly off the coils that held more than a half-mile of pipe. We put in and connected these runs to the 12-inch main in one day. All 40 acres were planted with corn that same day. We actually started at six in the morning and the planter came in at four o’clock.”

Prinsco's GOLDLINE® corrugated HDPE pipe provided the required perforation pattern for the subsurface drainage. The 4-inch diameter pipe was delivered to the farm in 3,000 foot-long coils. Geotextile wrap was not required and installation was done with a self-contained plow, eliminating the need for a more expensive and time consuming cut and cover operation.
